CASE REPORT

# ESTHETIC REORIENTATION OF TRAUMATISED MAXILLARY RIGHT CENTRAL INCISOR BY A NOVEL, FLEXIBLE POST SYSTEM AND CORE RECONSTRUCTION

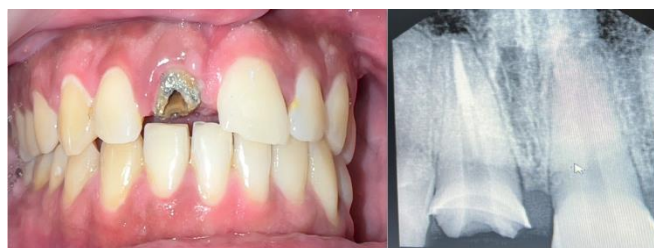
Fig 1: Pre Operative Photograph and Pre Operative Radiograph

1. Dislodged Richmond crown of tooth number 8. Graded as Esteves Correia Class II.
2. Ellis class 1 fracture of tooth number 9.
3. Deep dentinal caries in teeth number 1,16,17.
4. Dislodged restoration in tooth number 31
5. Orthodontic Findings - Anterior deepbite, lingually tipped Tooth No. 8, Labially tipped Tooth No.9, Crossbite of the distal aspect of Tooth no.11 with mesial aspect of Tooth no. 21, Angle's class 1 molar relation

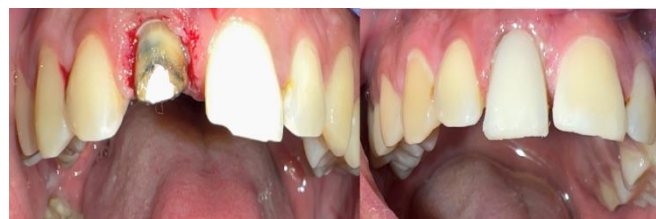
Fig 2: Post Operative picture of Day 0 showing soft tissue management and Tooth Number 9 restored and resized. Note the temporary crown on Tooth Number 8

Day 1: Composite restoration done on tooth number 9 (Fig 2)

Since aesthetics was our prime concern in this clinical scenario, we decided to restore and enhance tooth number 9 beyond its original contours to compensate for the size and shape discrepancy noted between the two central incisors when the Richmond crown was in place of tooth number 8. Thus, the Ellis class 1 fracture on tooth number 9 was restored with composite after selective etching under strict rubber dam isolation, followed by the enlargement of the mesial contour of the tooth to compensate for the size and shape discrepancy noted. Shade matching was achieved by placing and curing a small button of composite on the labial surface of tooth number 9.

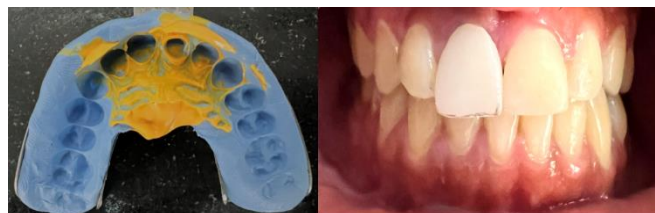
Fig 6: Final two stage impression and Bisque Trial with corrections marked

The patient reported back with a concern of contact between the prosthesis and his lower anterior natural teeth. The temporary crown was removed atraumatically since it was only cemented with a temporary cement. Requisite modifications to the crown preparation were carried out and another single stage Putty-Light body combination impression was made. A bisque trial (Fig 6) of a multi-layered zirconia crown was requested to suggest any corrections as required in the final prosthesis and the same was delivered on Day 23. All suggestions from the patient and our own observations were passed on to the laboratory for further processing.

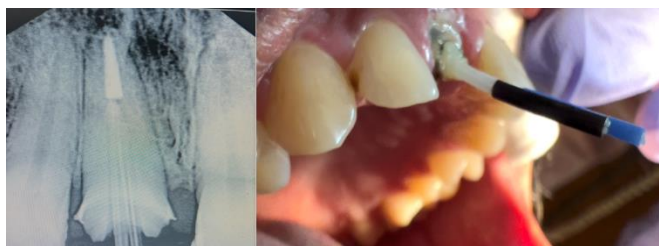
Fig 4: Check radiograph with post; Bundles of Biolight Plus posts bent labially to achieve adequate occlusal clearance for the core.

The Biolight Plus system features multiple fiber strands bundled within a sleeve, allowing customizable placement tailored to canal dimensions. To accommodate the patient's wide, previously prepared root canal, two post bundles (sizes 9 and 6) were used. Additionally, the system bonds to dentin via resin cement, reinforcing the tooth and lowering root fracture risks compared to cast posts in thin-walled canals. (Fig 4)

Self-adhesive resin cement (3M™ RelyX™ U200 Automix) was injected directly into the canal. Post bundle No. 9 was inserted immediately, followed by bundle No. 6 placed distally to achieve a tight fit. Prior to light-curing, a stainless-steel needle holder secured both bundles at the orifice level while they were tilted facially, aligned with tooth #9 as a reference. Following light-curing, the excess fiber bundle length was trimmed using surgical scissors to roughly half the coronal height of tooth #9. Core build-up material (ParaCore, Coltene Whaledent) was then applied, contoured, and a proper ferrule was prepared to accommodate a final zirconia crown. (Fig 5)

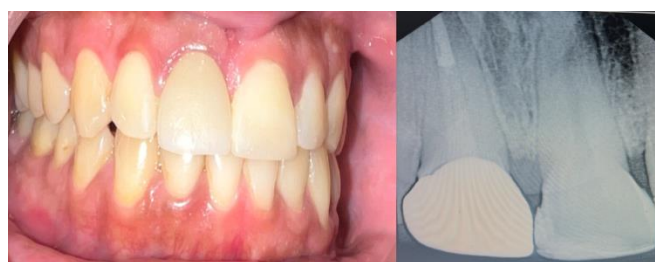
Fig 7: Post Operative radiograph immediately after crown cementation and Final restoration

The glazed final crown was checked for fit of margins, centric and eccentric contacts and esthetics. Upon approval by the patient and

meeting our satisfaction, the same was bonded using self-adhesive resin cement (3M RelyX U200) and tack cured for 5 seconds all around, excess cement was removed using an explorer and floss. Final curing was performed for 20 seconds all around and finally checked and verified to ensure no discrepancy.

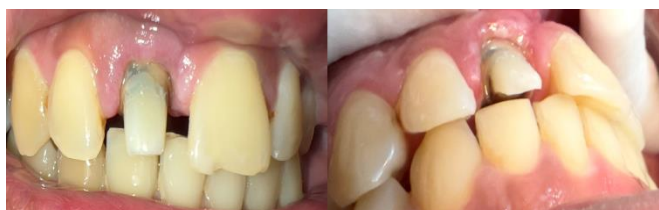
Fig 5: Tooth Number 8 after core build-up showing enough occlusal clearance obtained.

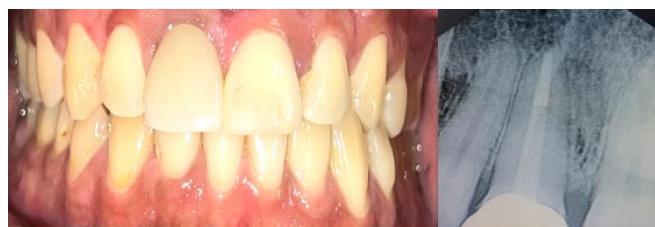
Ten month follow up was within normal limits with good soft and hard tissue health and no intervention was deemed necessary at that point. (Fig 8)

Fig 8: 10 month post operative radiograph and Clinical Photograph. Note the healing of the periapical region.
